HISTORIC AMERICAN ROOF TRUSSES

I. Scissor Trusses

THIS article is first in a series to discuss and illustrate the form, function and joinery of American timber-framed roof trusses of the past, showing typical examples with variations. The series was developed from original research under a grant from the National Park Service and the National Center for Preservation Technology and Training. Its contents are solely the responsibility of the authors and do not represent the official position of the NPS or the NCPTT. Further articles to appear in TIMBER FRAMING will treat Kingpost Trusses and Queenpost Trusses.

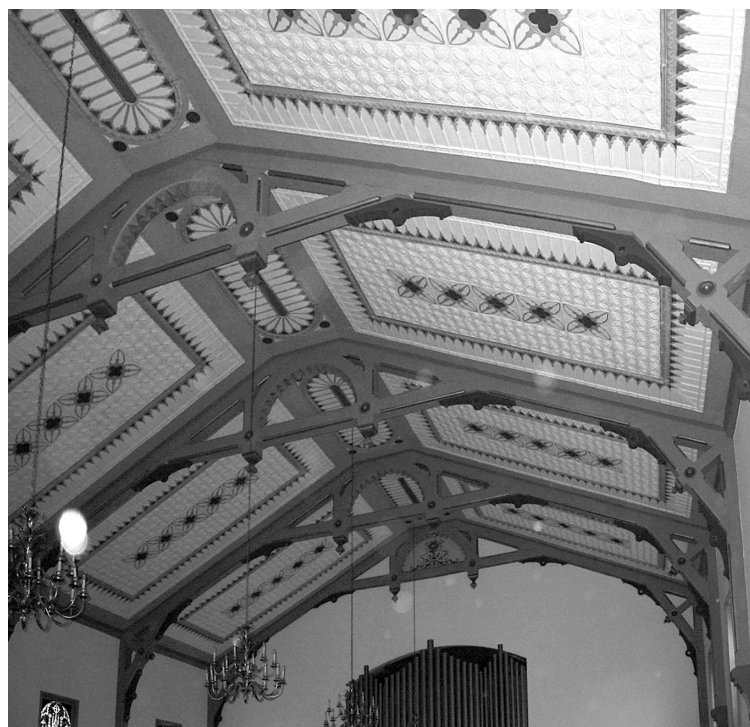
Scissor truss elevation and interior perspective view, Barton Congregational. Principal rafters (upper chords) are pitched at 12:12, scissor (lower) chords at 6:12. The collars, lightly fastened, appear to have served as raising aids, and were left in place. Light lines indicate decorative framing visible from audience room below. Truss terminations at plate, concealed from view by purlins in the attic, and lower tension rod ends, concealed by interior finish, are here drawn conjecturally.

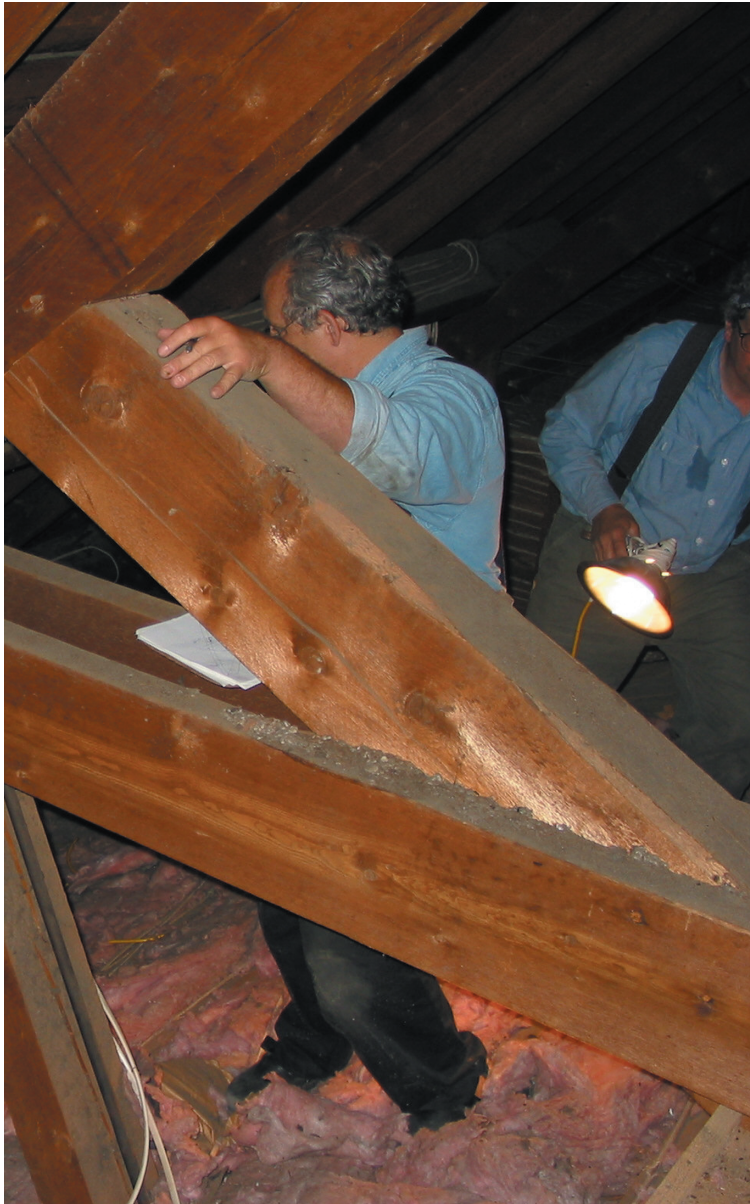
Researchers E. Levin and K. Rower (as Diogenes) in the attic of the Barton Congregational Church. Spruce scissor chord rises to meet principal rafter just above Levin's left hand. Untenoned strut combined with iron rod visible at lower left. Pair of 3x9 planks flanking strut and scissor chord appear to have been raising aids.
